Technical Report CERC-95-9
July 1995

Monitoring of the Yaquina Bay Entrance North Jetty at Newport, Oregon; Summary and Results

by Steven A. Hughes, Terri L. Prickett,
Michael W. Tubman, William D. Corson

Final report

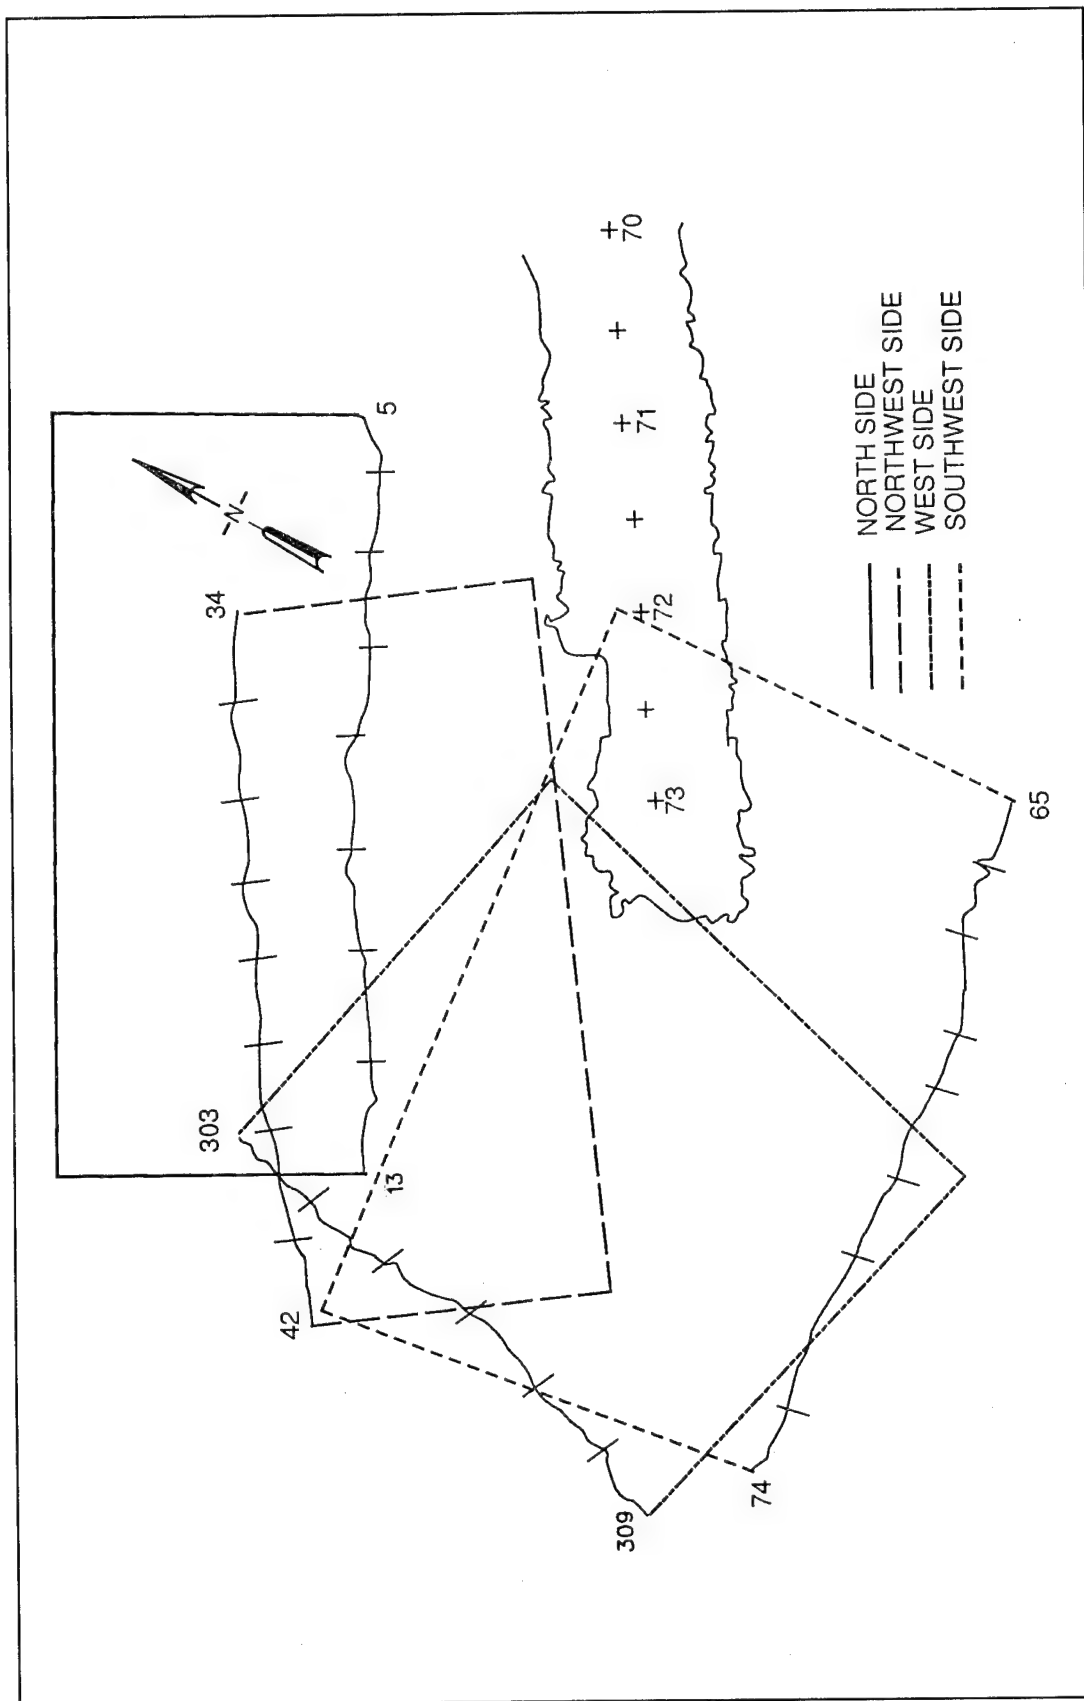
Figure 28. Yaquina Bay north jetty side-scan sonar analysis areas

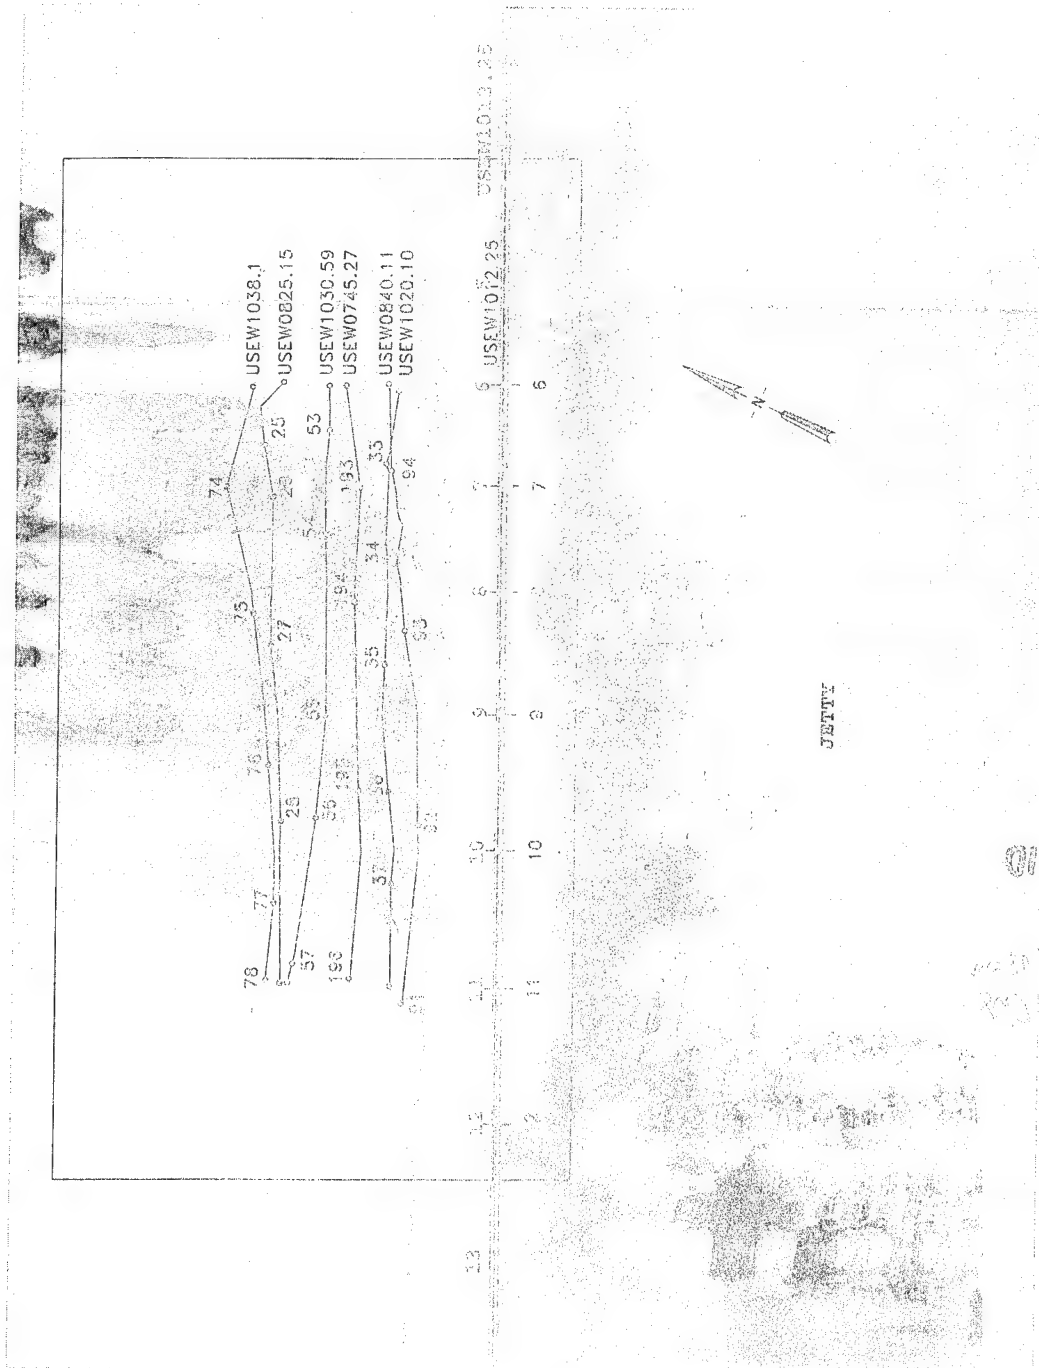
The side-scan sonar image of Figure 29 depicted fingers of rock to the north (top side) of track line USEW1038.1. These rock fingers have been

Figure 29. Side-scan sonar record along trackline USEW1012.25 for "north side of jetty" region

accentuated by geometric distortion. This same area of the seafloor is shown with a more correct appearance in the upper right-hand portion of the side-scan sonar image of Figure 27. The tick mark on the far right side of the side-scan sonar track line shown in Figure 27 is at approximately the same east-west position as event mark 7 on the image given in Figure 29.

Despite the geometric distortion problem, it is clear there are no rounded objects indicative of jetty armor stones on the side-scan sonar image near event mark 74 on track line USEW1038.1 (Figure 29). Therefore, it is concluded that the roughness element visible on the corresponding profile on Figure 30 is a result of the track line crossing the reef rock finger indicated on the side-scan sonar image at event mark 74.

A similar conclusion is drawn regarding the roughness elements shown on Figure 30 profile USEW0840.11 in the vicinity of event mark 93. As seen on Figure 29, this echo sounder track line overlays reef rock fingers, but there is no indication of armor stones in the image near event mark 93. The round image approximately halfway between event marks 93 and 94 along track line USEW0840.11 was most likely caused by the presence of a hole in the reef rather than an armor stone. Interpretation of the remaining four bathymetric profiles shown in Figure 30 resulted in the conclusion that all six echo sounder track lines crossed the Yaquina Reef to the north of any armor jetty stones.

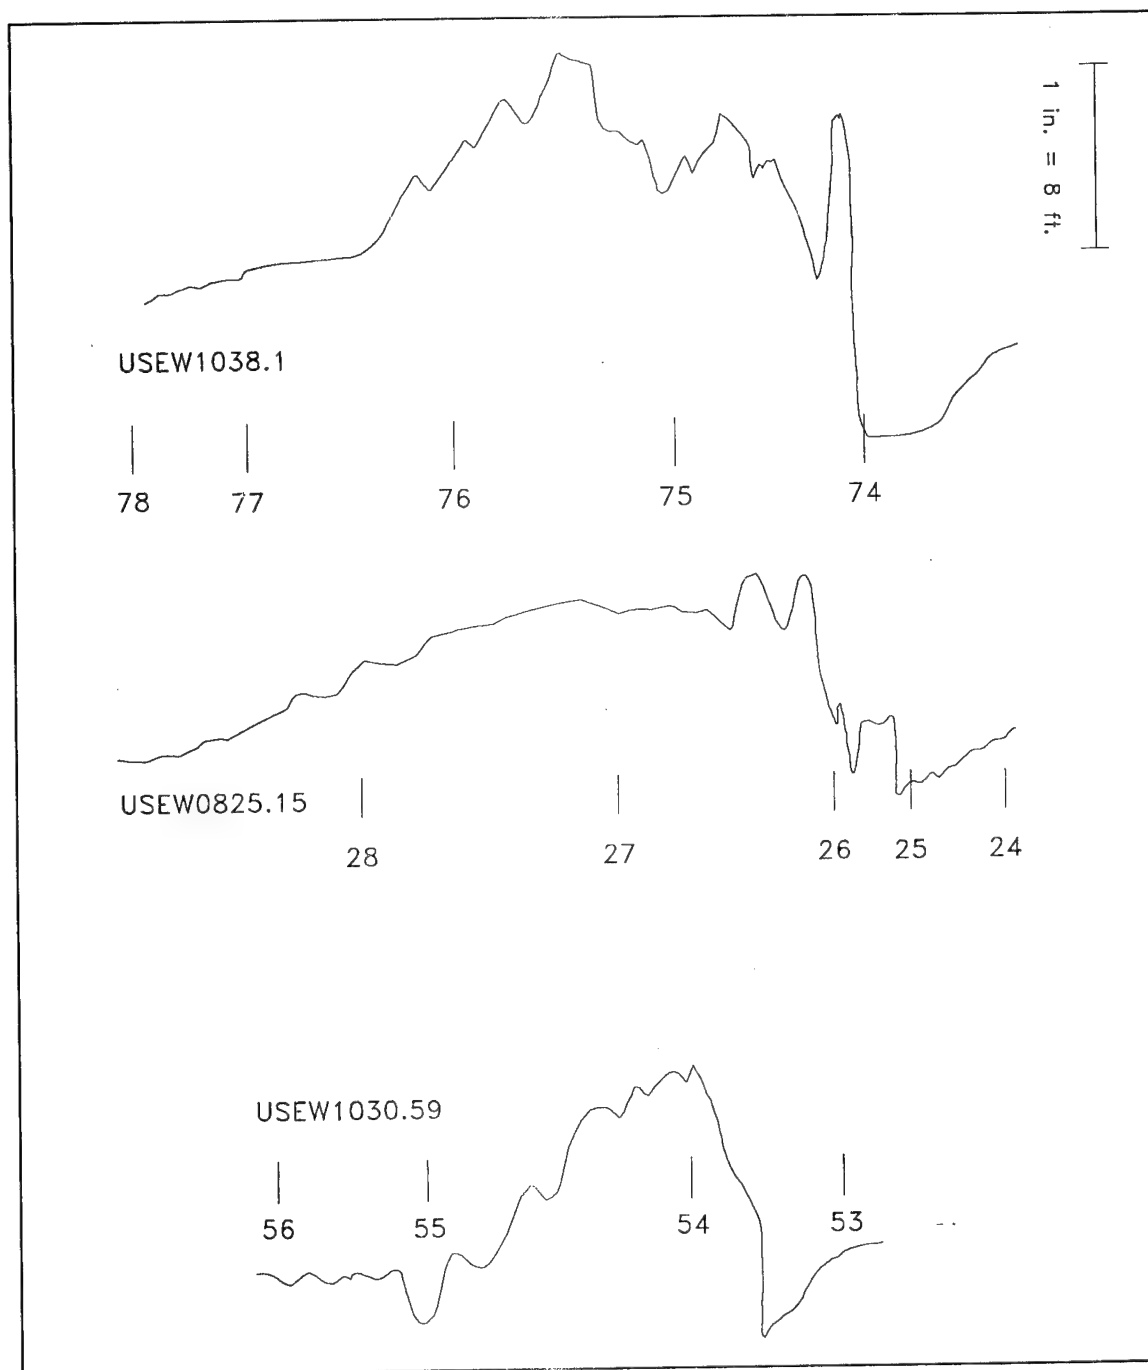
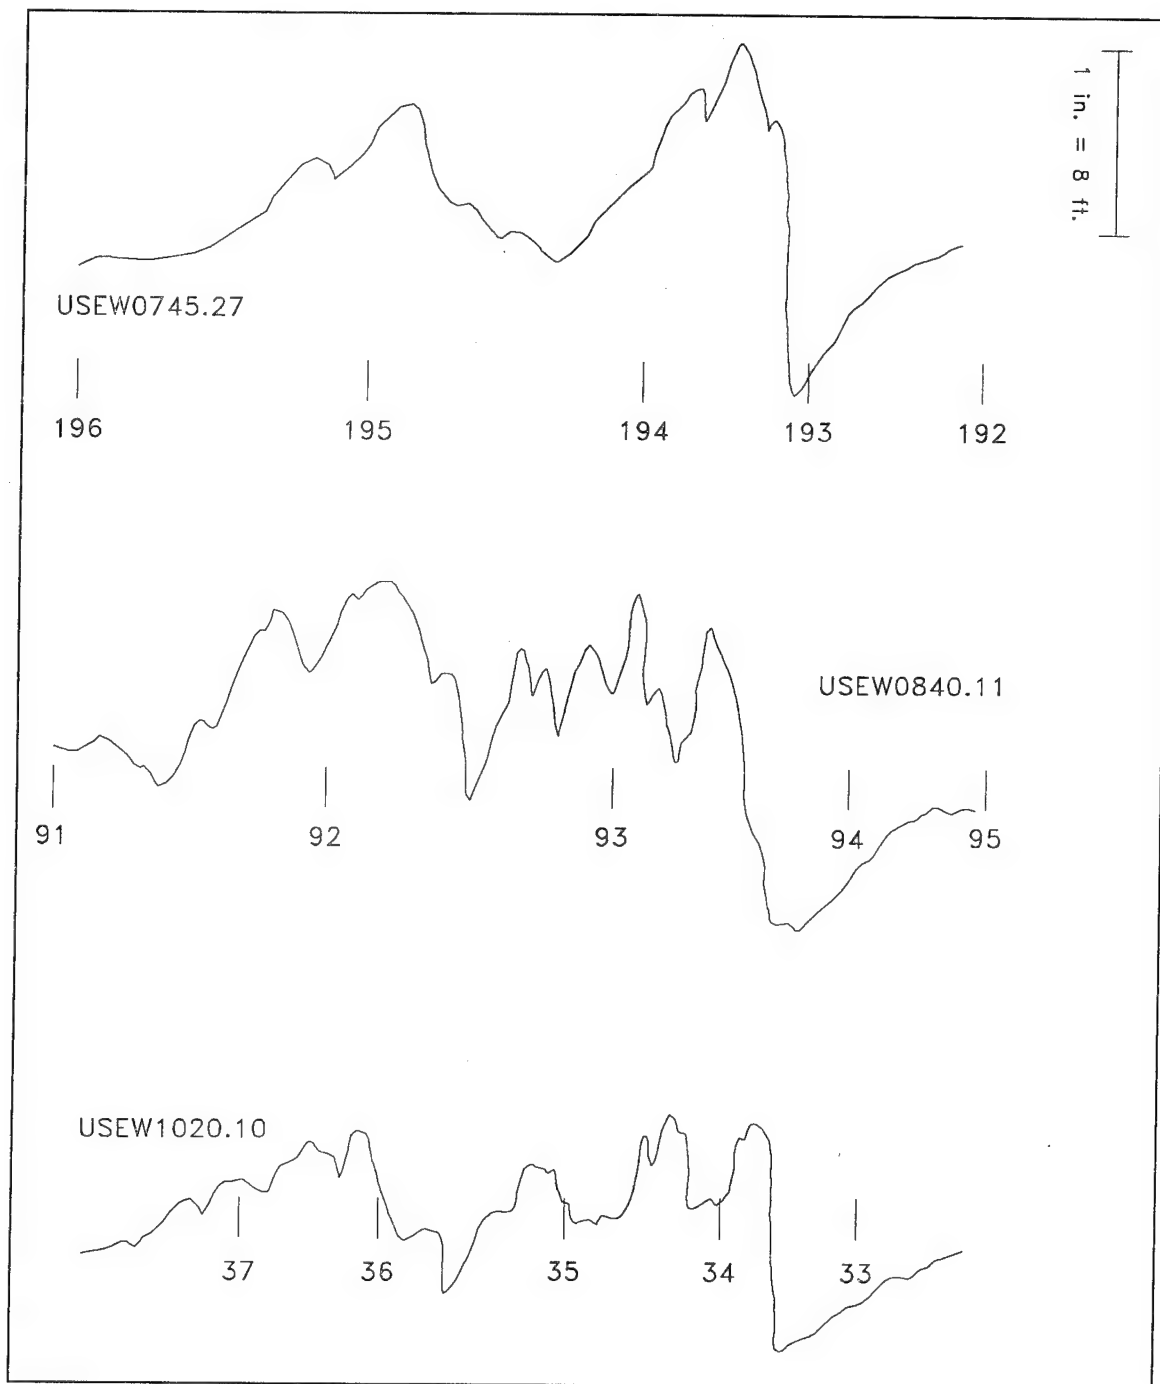
Bottom profiles for the echo sounder trace lines overlain on Figure 29 are displayed in Figure 30. Generally, the profiles are arranged in order beginning with the most northerly profile and moving closer to the side-scan sonar track. The bathymetric traces are relatively smooth and hummocky with the exception of a roughness element near event mark 74 on track line USEW1038.1 (top profile on page 89), and some roughness elements around event mark 93 on track line USEW0840.11 (middle profile on page 90).

Figure 30. Echo sounder profiles for "north side of jetty" region (Continued)

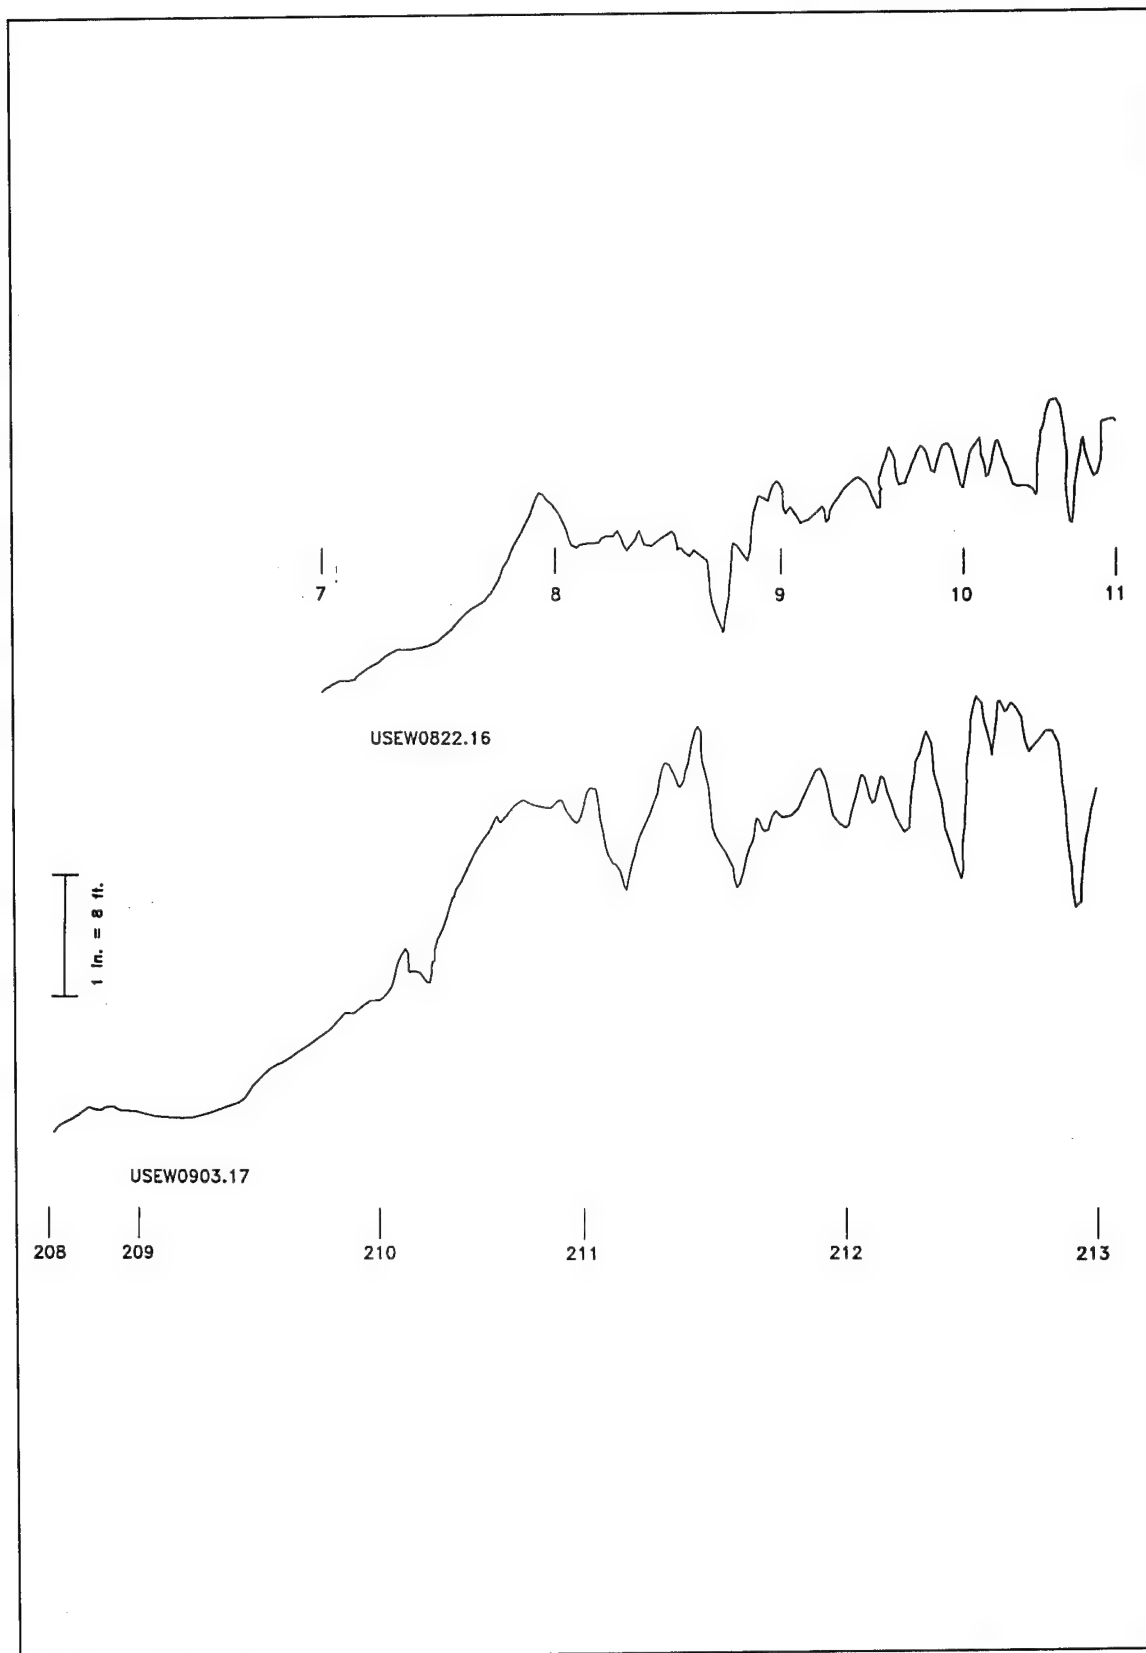
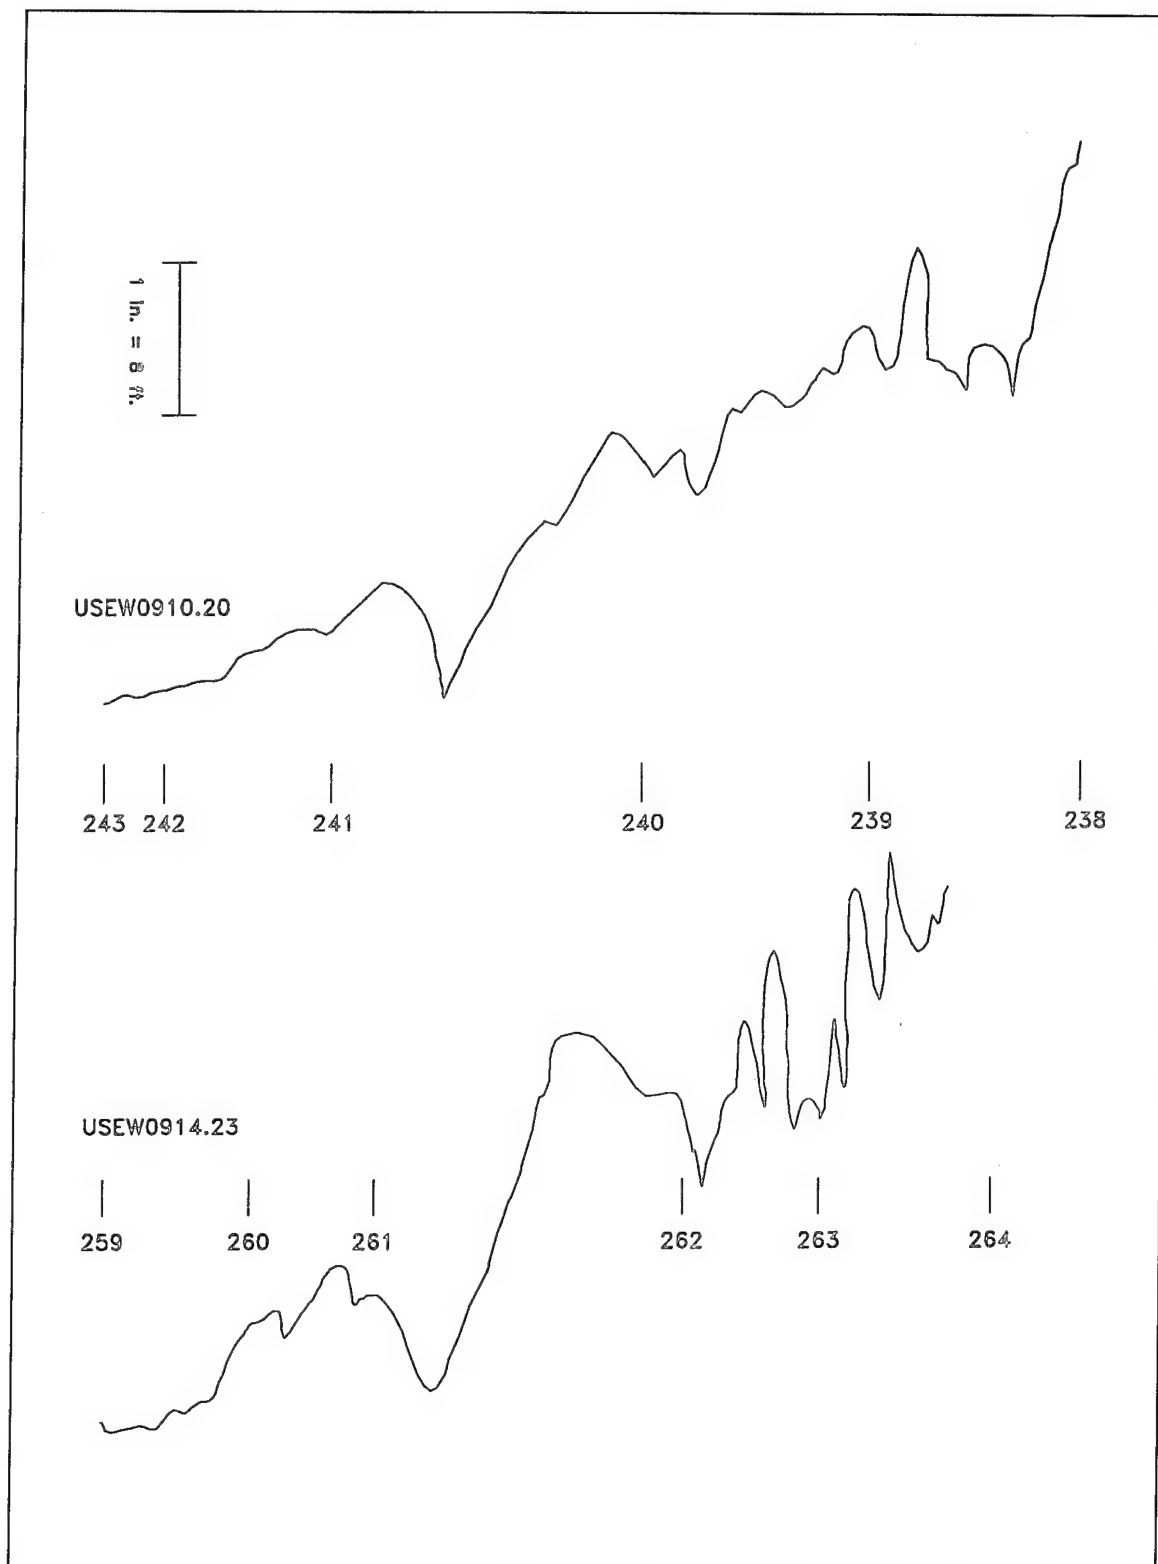
Figure 32. Echo sounder profiles for "northwest side of jetty" region (Continued)

On the corresponding bathymetric profile (bottom profile on page 93) there is a peaked bottom feature shown between event marks 211 and 212. Interpretation of the side-scan sonar record in this location concluded that this peaked feature is a wide rock finger. Around event mark 212 there are evenly spaced roughness elements similar to those seen around event mark 10 on track line USE0822.16. These roughness elements are also interpreted to be overlapping jetty stones. In conclusion, the interpretation for track line USEW0903.17 was that the track line crossed the Yaquina Reef beginning at event mark 210, and continued until event mark 212, where it then crossed over the toe of the north jetty.

Roughness elements also appeared on bathymetric profile USEW0910.20 near event mark 239 and on profile USEW0914.23 starting near event mark 262 and continuing toward event mark 264 (see Figure 32). These roughness elements were interpreted to be individual jetty stones resting on the seafloor. The corresponding side-scan sonar image of Figure 31 shows the transition from unconsolidated sediment to rock to be at event mark 241 along track line USEW0910.20 and at event mark 260 along track line USEW0914.23.

The interpretation for these two echo sounder track lines was that track line USEW09010.20 began crossing over the reef at event mark 241, and continued until mark 239 where it crossed over the jetty. Similarly, trackline USEW0914.23 started crossing the reef at event mark 260 until event mark 262, where it started crossing the jetty. Finally it is noted that all four bathymetric profiles clearly show the smooth hummocky appearance interpreted to be reef rock on their western end (left side of profiles in Figure 32).

Along track line USEW0910.20 just to the landward side (right side) of event mark 241 (see Figure 31) the side-scan sonar data indicated a region that is definitely rock. However, the smooth region in the bathymetric profile for this area (see Figure 32 between event marks 241 and 239) is not at all representative of jetty armor stones. Consequently, there is little doubt that a

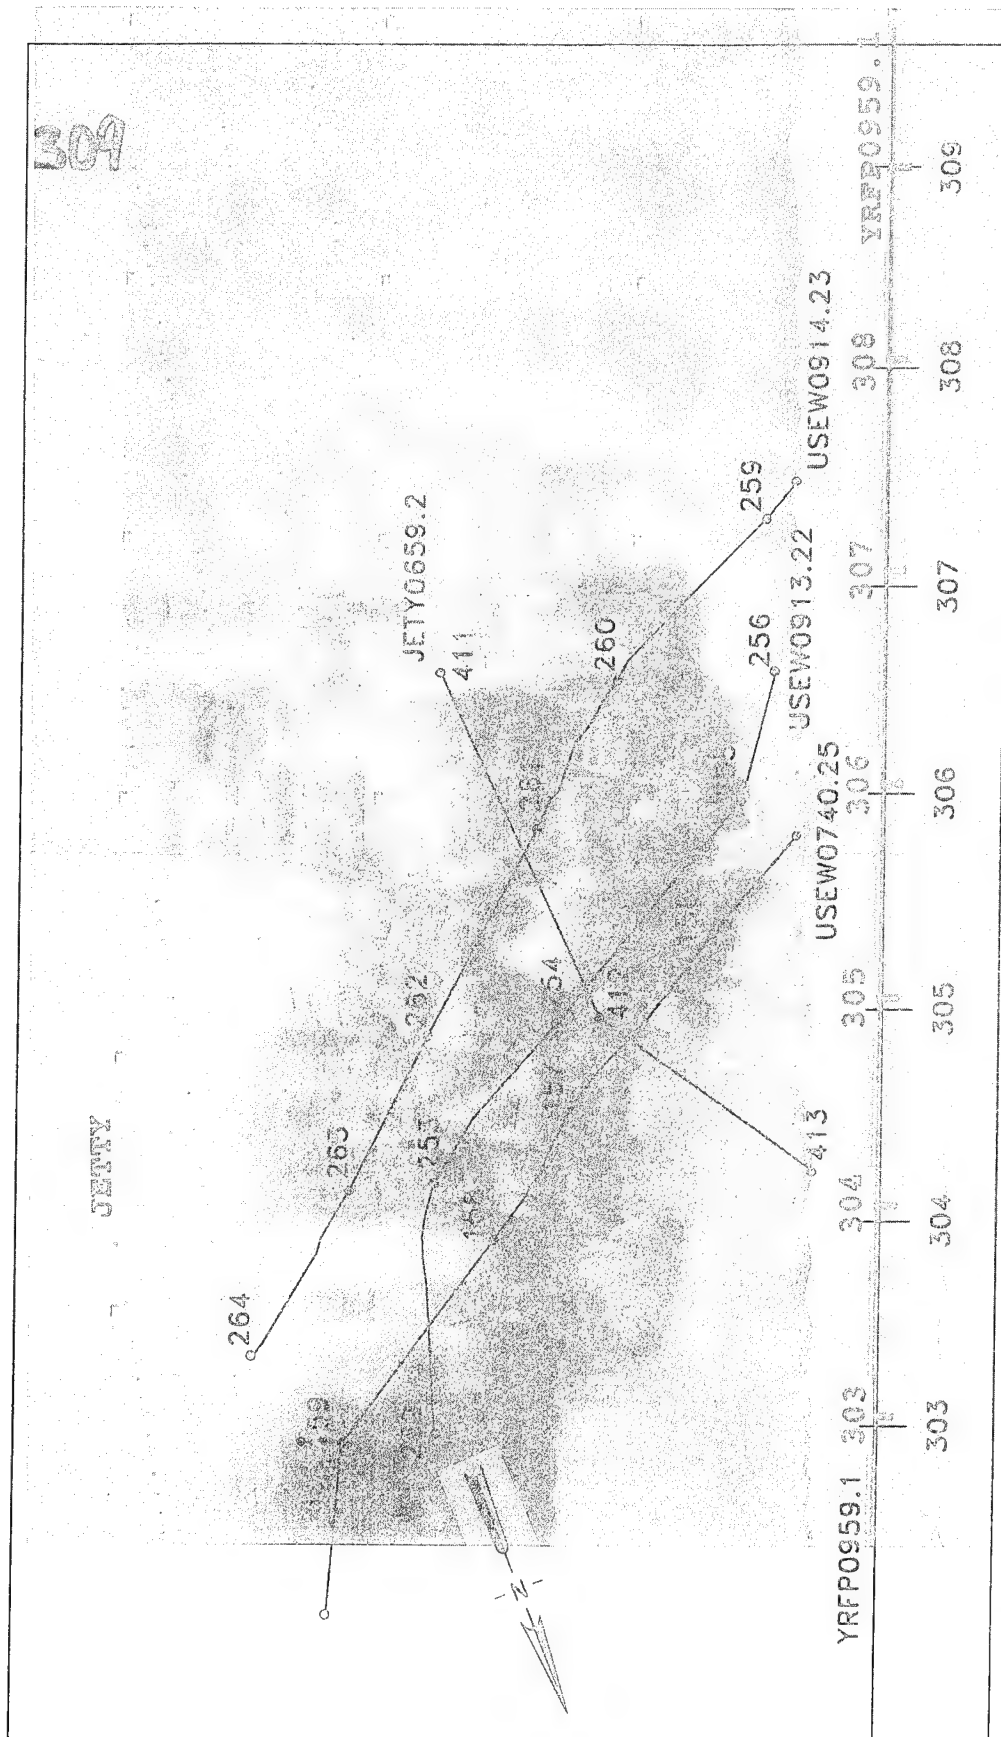
Demarcation between unconsolidated sediments and reef rock is clearly discernable on the side-scan sonar image of Figure 33. This transition is just seaward of event mark 412 along trackline JETY0659.2, halfway between event marks 155 and 156 along trackline USEW0740.25, at event mark 255 along track line USEW0913.22, and halfway between event marks 259 and 260 along track line USEW0914.23.

Figure 33. Side-scan sonar record along trackline YRFP0959.1 for "west side of jetty" region

corresponding side-scan sonar image of Figure 33 showed no rounded objects along this track line. However, there were light areas that may be areas of sand. The interpretation from the echo sounder and side-scan sonar data is that trackline JETY0659.2 passed entirely over reef rock which contained isolated sand pockets overlaying the Yaquina Reef.

The side-scan sonar image of Figure 33 was too dark to permit a clear interpretation along echo sounder track line USEW0913.22 in the region of event mark 252. Therefore, the bathymetric profile around event mark 252 cannot be interpreted with certainty. The small regular roughness elements present on this profile in Figure 34 around event mark 253 exhibit the shape of overlapping jetty armor stones, and this interpretation is confirmed by the rounded images returned from the side-scan sonar around this event mark. The bathymetric profile also has the smooth hummocky appearance of reef rock between the offshore boundary of the reef at event mark 255, shoreward until event mark 254. The conclusion for echo sounder trackline USEW0913.22 was that the track line crossed from unconsolidated sediments to reef rock near event mark 255 and passed over the Yaquina Reef until event mark 254, where the trackline crossed over the north jetty toe.

The bathymetric profile for trackline USEW0914.23 on Figure 34 shows a region of roughness elements between event marks 262 and 264 that have correct dimensions to be individual jetty armor stones. Rounded objects that appear to be jetty armor stones are clearly seen in this region in the Figure 33 side-scan sonar image. From event mark 262 seaward to halfway between event marks 260 and 259 the rock formation has the smooth hummocky appearance of the Yaquina Reef. Therefore, echo sounder trackline USEW0914.23 passed over the seaward edge of the reef between event marks 259 and 260, crossed over the reef until event mark 262, then crossed over the toe of the north jetty.

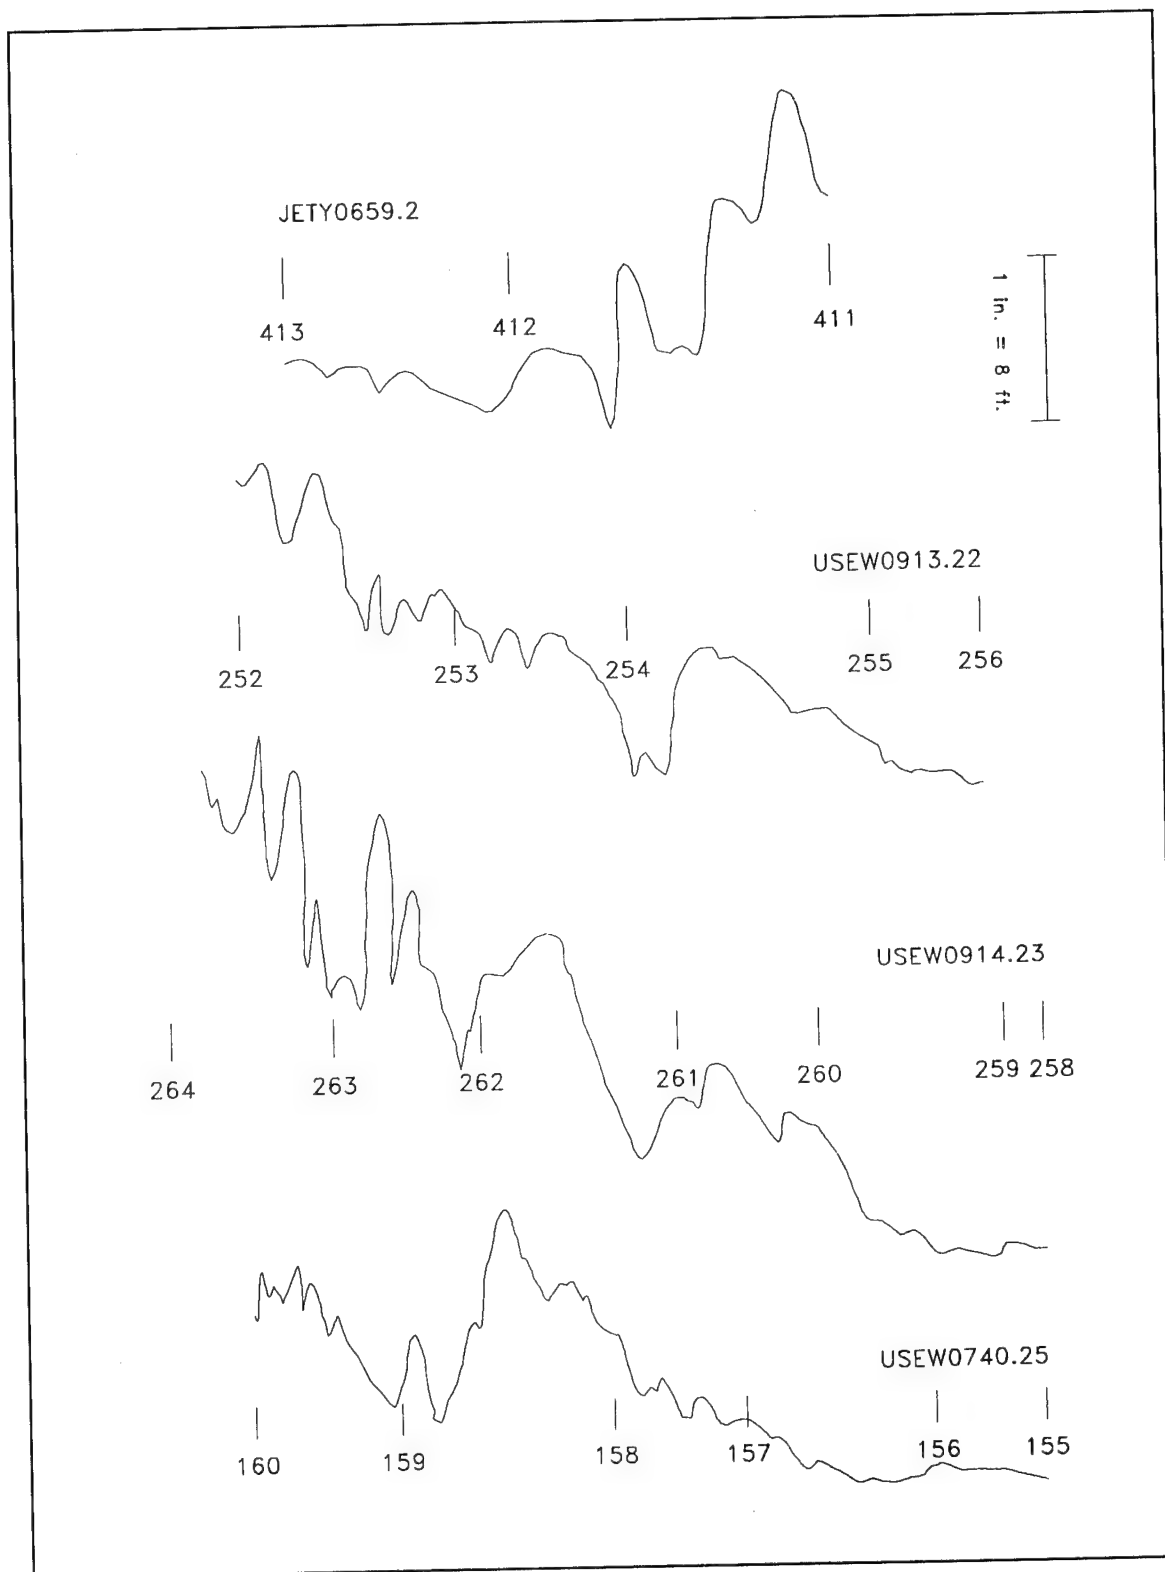
The bathymetric profile for track line JETY0659.2 shown on Figure 34 is relatively smooth, and the large roughness elements are generally wider in the horizontal and shorter in the vertical than those of individual jetty stones. The

Figure 34. Echo sounder profiles for "west side of jetty" region

The bathymetric profile for trackline USEW0740.25 shown on Figure 34 is also relatively smooth until halfway between event marks 159 and 160. Unfortunately, the corresponding side-scan sonar image is no help in this region because the return signal is very dark, and it is hard to discern any rounded features. It was tentatively concluded that trackline USEW0740.25 crossed over the seaward edge of the Yaquina Reef between event marks 155 and 156, and passed over the reef until between event marks 159 and 160 where small, regularly spaced roughness elements were recorded that may be overlapping jetty armor stones.

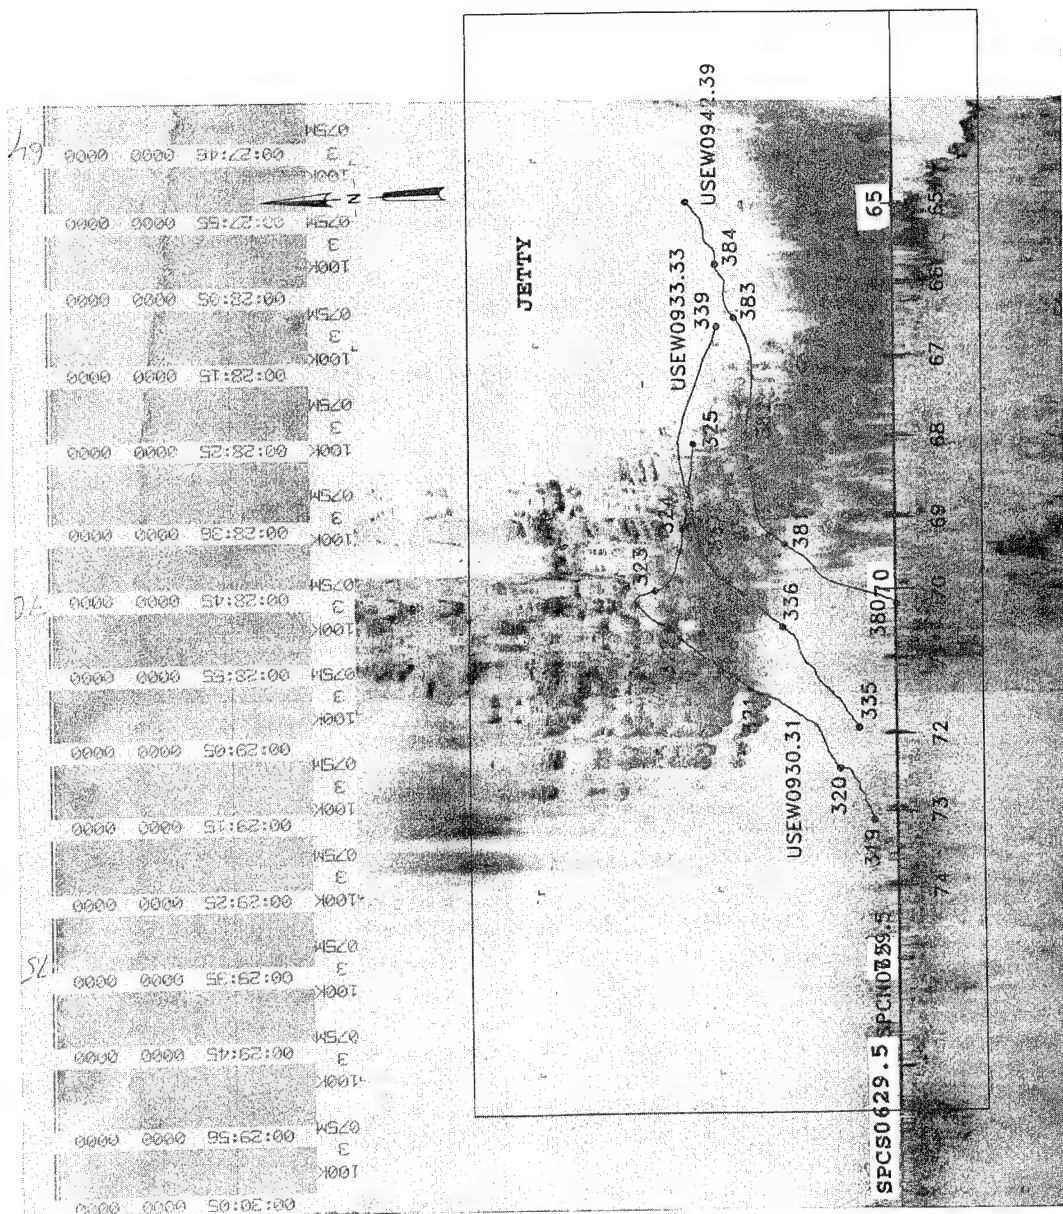
Figure 35. Side-scan sonar record along trackline SPCS0629.2 for "southwest side of jetty" region

The side-scan sonar image of Figure 35 indicated that the transition from offshore unconsolidated sediments to rock occurred along echo sounder track-line USEW0930.31 near event mark 321, along track line USEW0933.33 between event marks 336 and 337, and along trackline USEW0942.39 between event marks 381 and 382. All three bathymetric profiles on Figure 36 showed a large scour trench just seaward of the rock area (southwest of the north jetty tip).

The identified rock portions of all three bathymetric profiles contained small regularly spaced roughness elements characteristic of overlapping jetty armor stones. Rounded objects were also seen in the Figure 35 side-scan sonar image over all portions that were indicative of rock. None of the bathymetric profiles had portions containing the smooth hummocky appearance of reef rock, with the possible exception of around event mark 322 along trackline USEW0930.31. However, the interpretation of these data in conjunction with other data led to the conclusion that there is no exposed reef in this immediate area. The presence of the deep scour trench immediately seaward of the jetty supports the contention that the toe of the north jetty in this region is resting on sand rather than resting on a portion of the reef that was covered with sand.

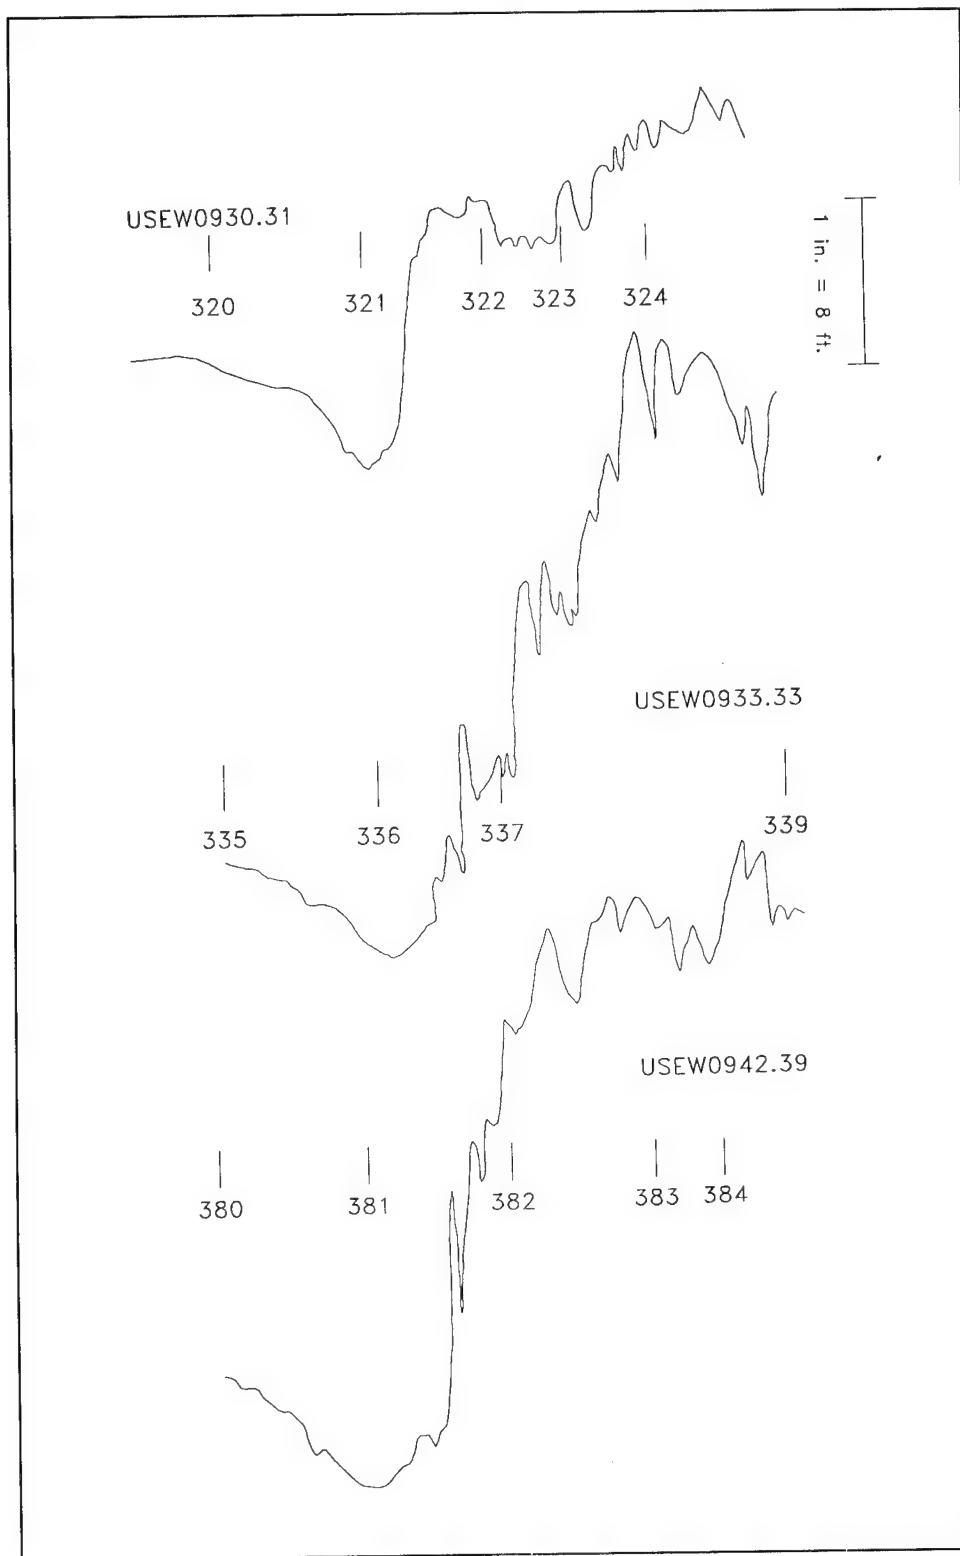
Figure 36. Echo sounder profiles for "southwest side of jetty" region

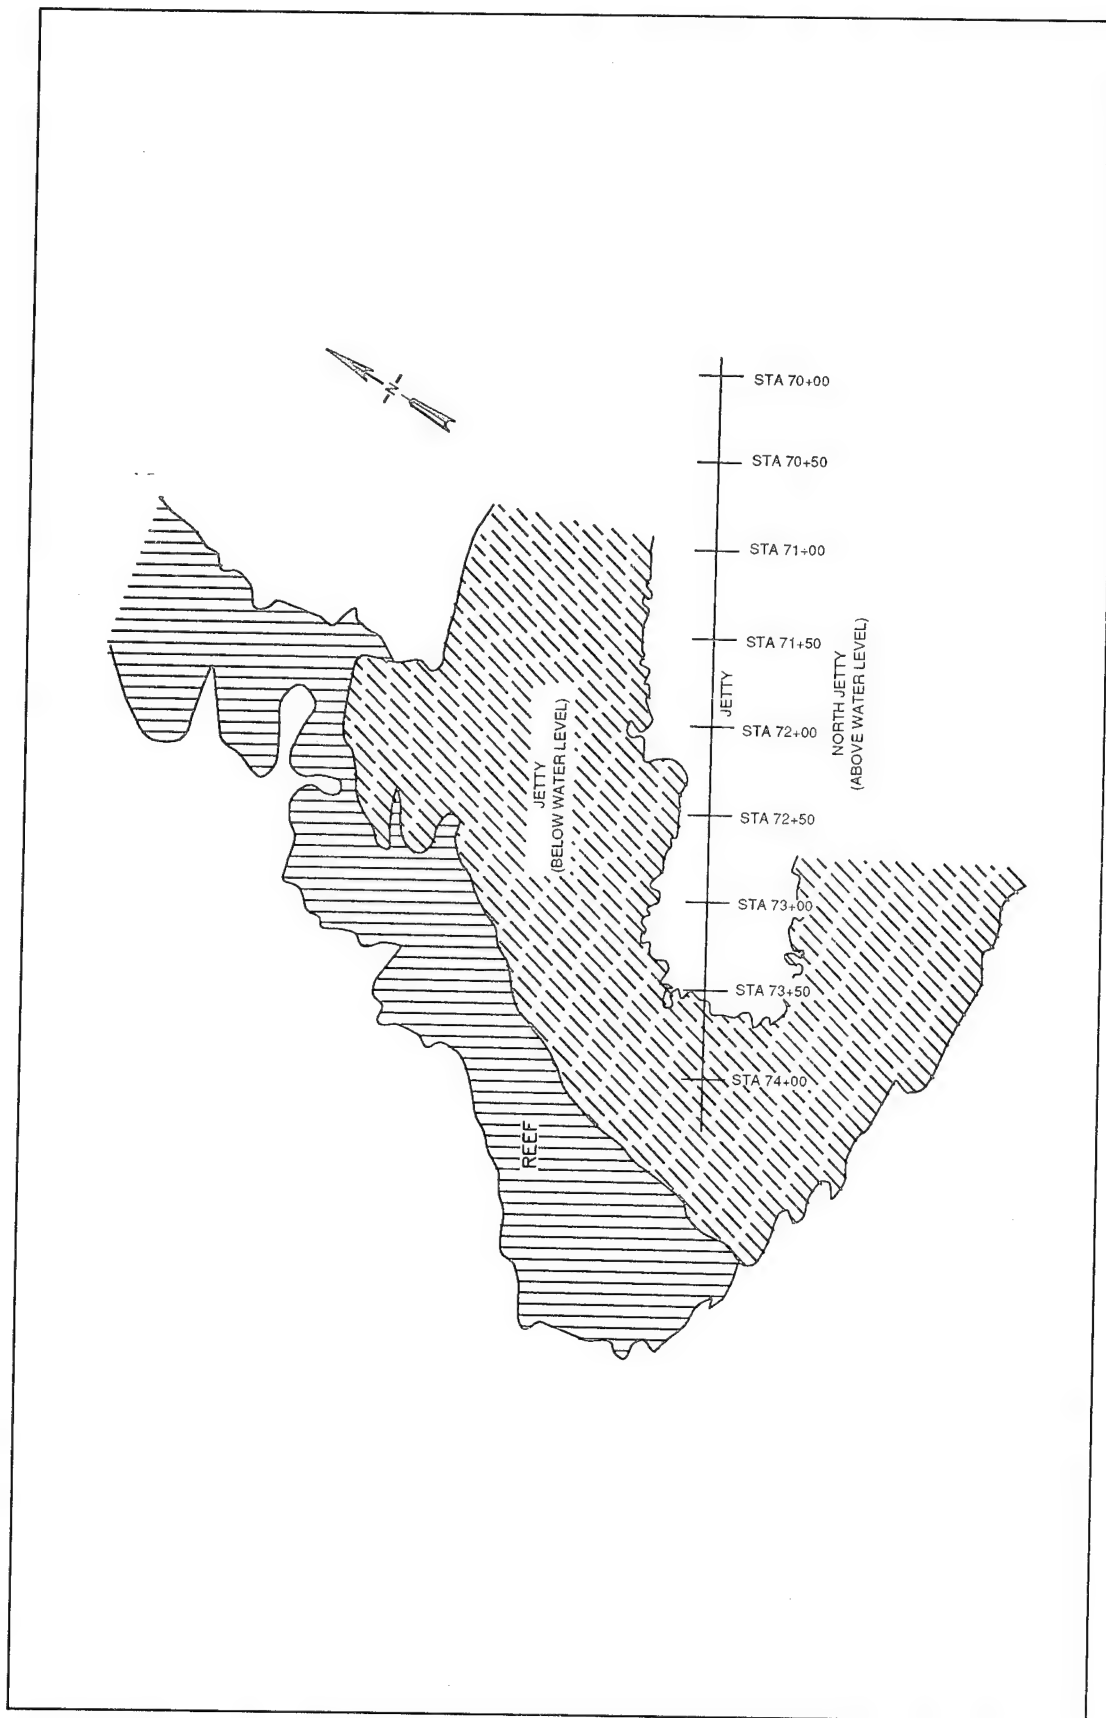
The four side-scan sonar images presented in Figures 29, 31, 33, and 35 were used to delineate the border between rock and unconsolidated sand around the Yaquina Bay north jetty head. This demarcation line was drawn on Figure 37 to show its position relative to the above-water portion of the north jetty.

The transition from reef rock to jetty armor stones was also marked on the chart in Figure 37 using all 78 available bathymetric profiles collected in the four areas surrounding the jetty head. These reef-to-stone transition locations were determined using the four side-scan sonar images in conjunction with the echo sounder profiles that showed roughness elements. Analysis was performed similar to that described above.

Figure 37. Position of Yaquina Bay north jetty relative to Yaquina Reef

portion of the Yaquina Reef sticks out seaward of the northwest tip of the Yaquina Bay north jetty. However, interpreting roughness elements on the bathymetric profiles as jetty armor stones involved a certain degree of subjectivity. Therefore, the line marking the toe of the north jetty on Figure 37 is not absolutely definitive.
